Quantifying the seismic resilience of bridges: a pathway towards a Resilience-Based Design

A.I. Sarkis & A. Palermo

ABSTRACT: The loss of functionality of road networks during the past Canterbury (2010-2011) and Kaikoura (2016) earthquakes has questioned New Zealand's established seismic resilience. The excessive direct and indirect costs due to downtime and non-structural damage highlighted the need to move towards new performance indicators. Resilience holds the key to describe the performance of modern structures by requiring low failure probabilities, reduced consequences from failures, and less recovery time. Combining the concepts of resilience directly with the structural design process can increase the confidence in implementing damage-resistant technologies to reduce the damage of bridges in an earthquake. Furthermore, translating resilience measures with concise and meaningful terms to decision makers will lead to a better understanding of the benefits of mitigation.

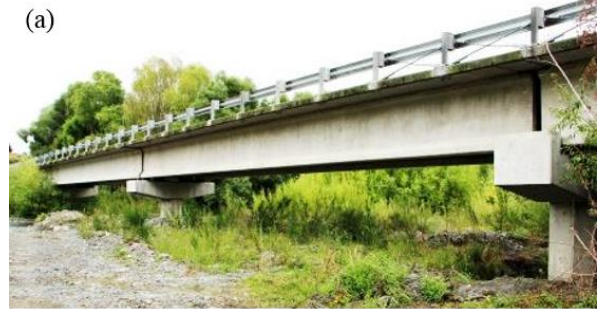
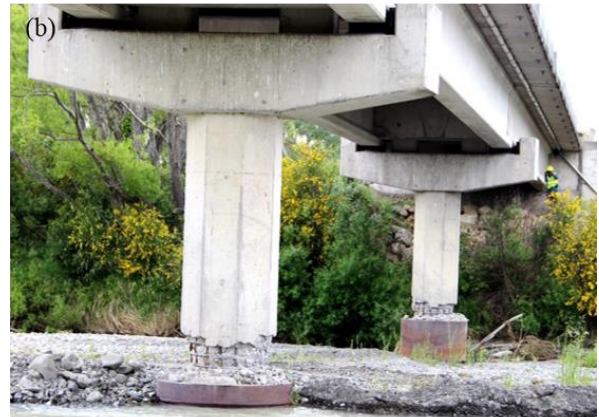
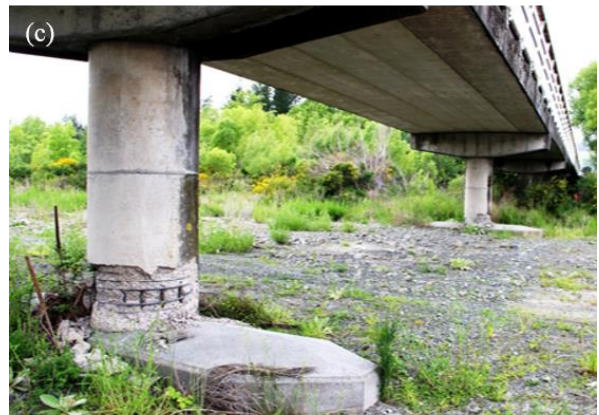
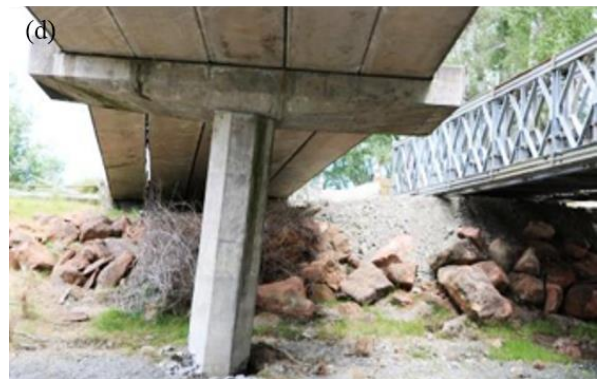
Figure 3. Bridges under study: (a) Lottery River Bridge; (b)

The Lottery River, Lower Mason River, Mason River, and Wandle River bridges (Figure 3) are structurally similar to one another. They are all multi-span precast concrete bridges supported on single column piers with hammer head pier caps. Further structural details are summarized in

In the way they resist lateral loading, the Lottery River (Figure 3a) and Lower Mason (Figure 3b) bridges are identical. The transverse interaction has been isolated by the omission of transverse shear keys at the central pier (Palermo et al., 2017). In addition, they use a rudimentary form of seismic isolation under transverse loading such that they can displace an appreciable amount on the supporting elastomeric bearings before contacting the shear keys. As a result,

The longitudinal interaction between each half of the bridge has been isolated by a movement joint with knock off detail. The deck beams are tied together longitudinally except over the central pier. The beams rest on wide seats, thus, all piers resist longitudinal lateral loading, except the central pier, which is effectively much more flexible. Until the beams contact the shear keys, the overall transverse response

Similarly, the Mason River Bridge (Figure 3c) is split in two with a central movement joint. There are transverse shear keys at the abutments and internal longitudinal shear keys and linkage bars over all of the piers except the central pier. At the central pier, provision is made for longitudinal movement with loose linkage bars but steel plate lateral support stubs cast into the piers restrain the transverse movement. Therefore, the overall transverse response can be thought of as the deck having a curved displaced shape where the largest transverse displacement occurs at the central pier (Palermo et al., 2017).

The Wandle River Bridge (Figure 3d) is curved in plan and has a slope in the longitudinal direction. Linkages, shear keys and elastomeric bearings restrain the transverse and longitudinal movement over the piers, but only linkage bars resist both the transverse and longitudinal movement at the abutments. Longitudinal movement towards the backfill at the abutments is resisted by the abutment back-wall which is cast against the beams.

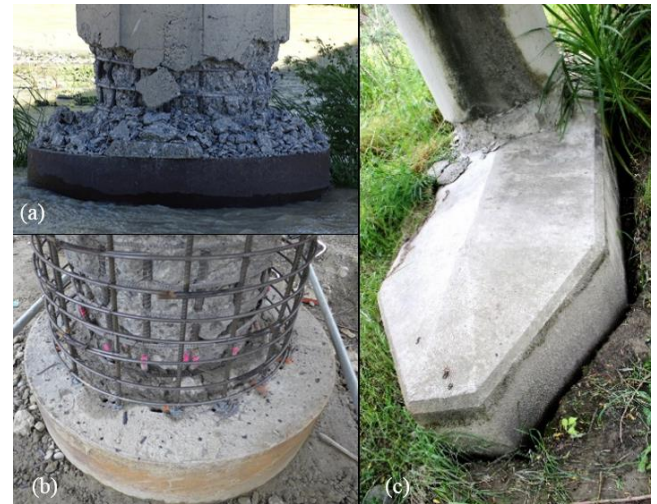
Figure 8. Plastic hinge repair: (a) PH in Lower Mason Bridge; (b) repair of PH by epoxy grout bars; (c) geometry at Mason River Bridge PH zones.

The structural scheme can play a part in the repair strategy, costs and hence resilience. In the case of monolithic bridges, repair of PH should be considered at the design stage. On the Lottery and Lower Mason bridges, the 1.5m diameter cylinder foundations located directly beneath the 1.0m diameter columns of the piers simplified the repair (Figure 8a). New reinforcement could be doweled into the existing pile and the pier re-cast, restoring the moment capacity of the column (Figure 8b). In contrast, for the Mason Bridge, repair is more difficult due to the shape and size of the pier cap (Figure 8c), as the geometry will make it very difficult to dowel in additional bars in and re-cast concrete. The result will be a significant repair cost and potential downtime for the structure.

Designing and detailing monolithic connections taking into account the repair strategy for different design level events would optimize the recovery after an earthquake event. Furthermore, if the bridges were designed for damage avoidance, incorporating energy
